# **U.S. 301 PROJECT DEVELOPMENT**

## **DETERMINATION OF ELIGIBILITY REPORT**

**St. Georges, Pencader, and Appoquinimink Hundreds,  
New Castle County, Delaware**

## **Volume II: Narratives and CRS Forms for N05191 to N13309**

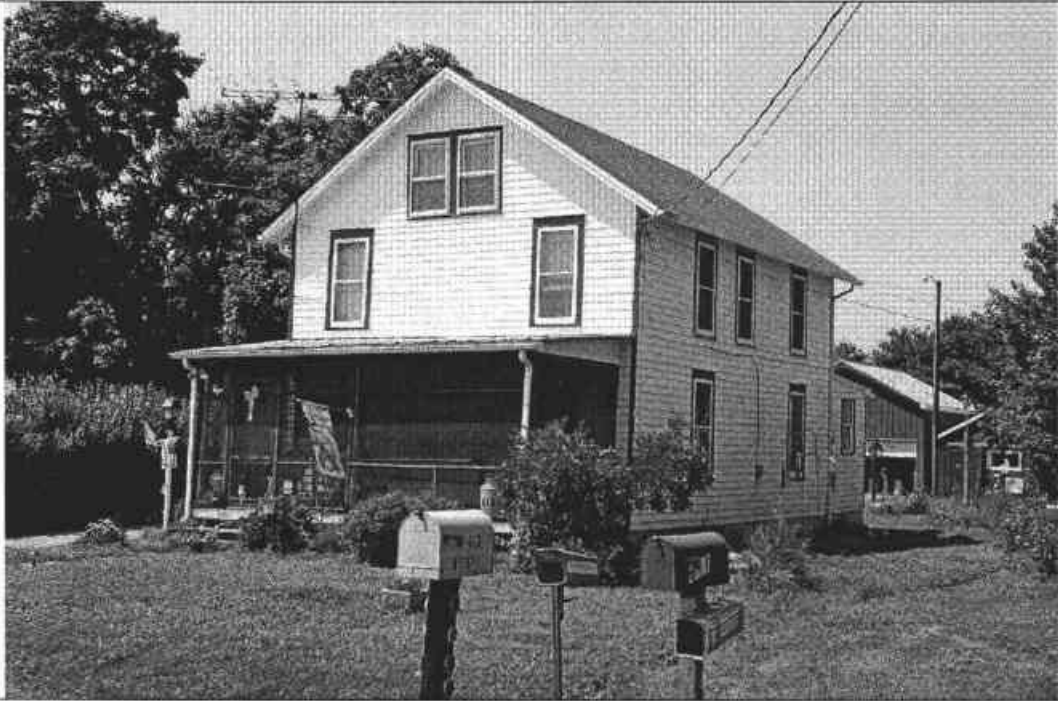
N05235. Photograph 1: Kate Kaiser House, overview of house, view to northwest. Note simple vernacular style and screened in porch.

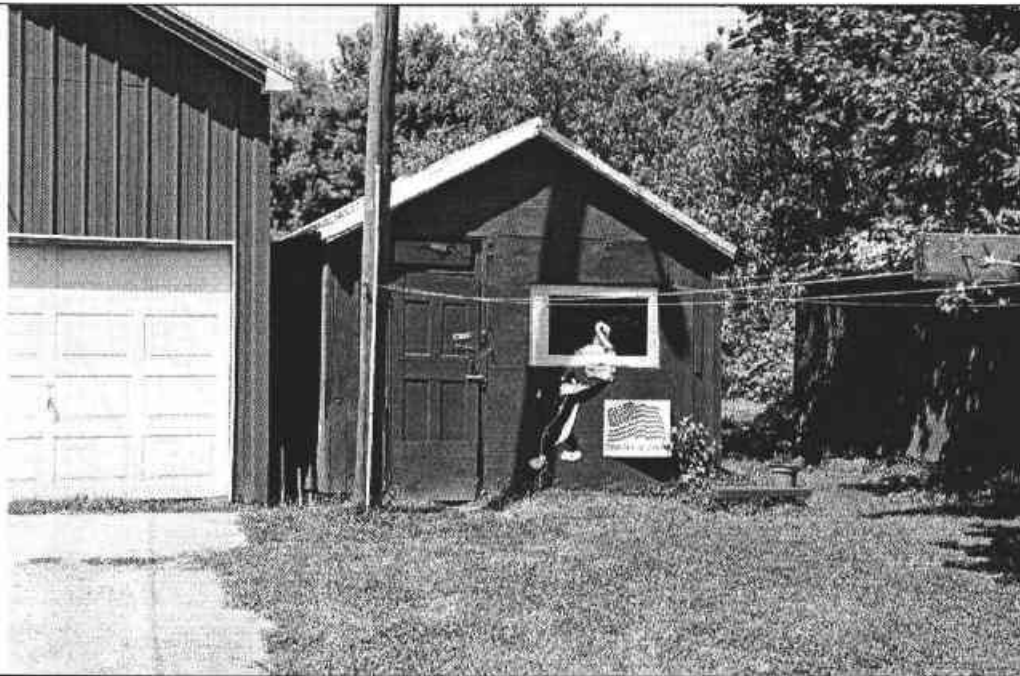
N05235, Photograph 2: Kate Kaiser House, *circa*-1920 garage, south elevation, view to north. Note filled in opening, pedestrian door and modern window.

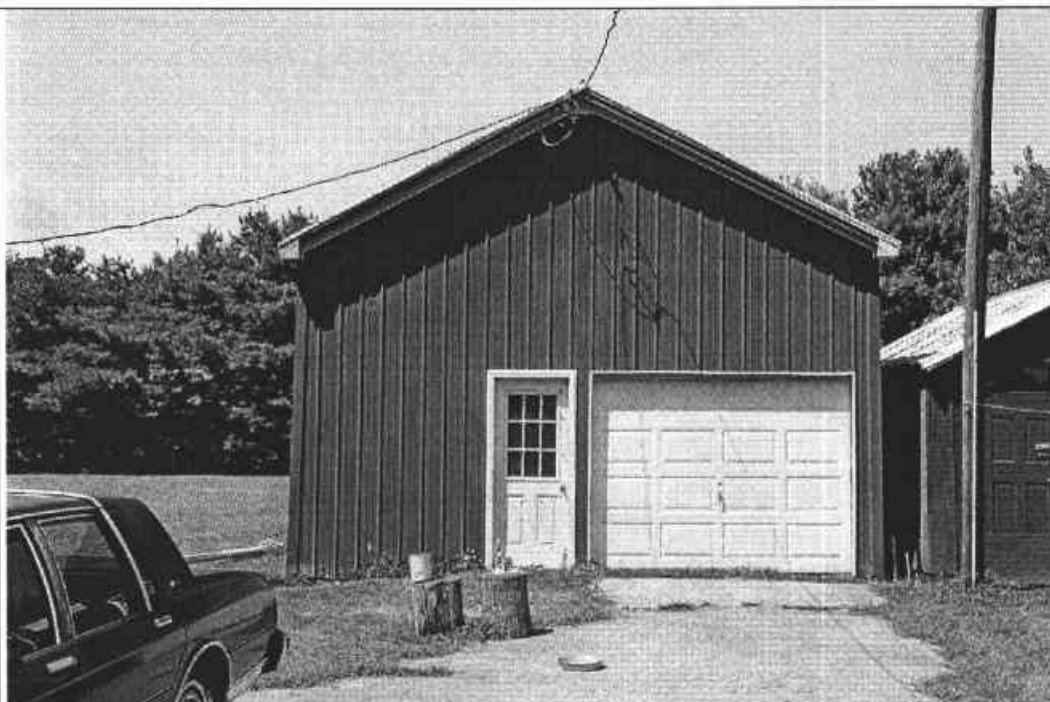
N05235. Photograph 3: Kate Kaiser House, *circa*-1940 garage, south elevation, view to north. Note replacement cladding, modern overhead garage door, and modern pedestrian door.

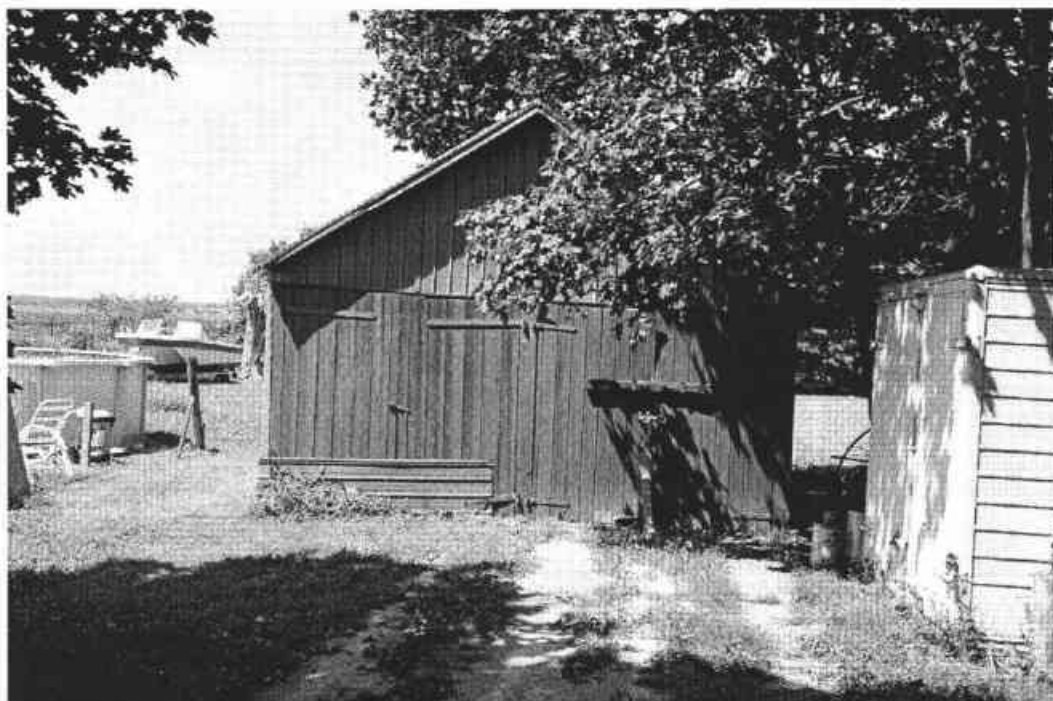
N05235. Photograph 4: Kate Kaiser House, barn, south elevation, view to north. Note the truck bed that has been converted into a darkroom on the right side of the photograph.

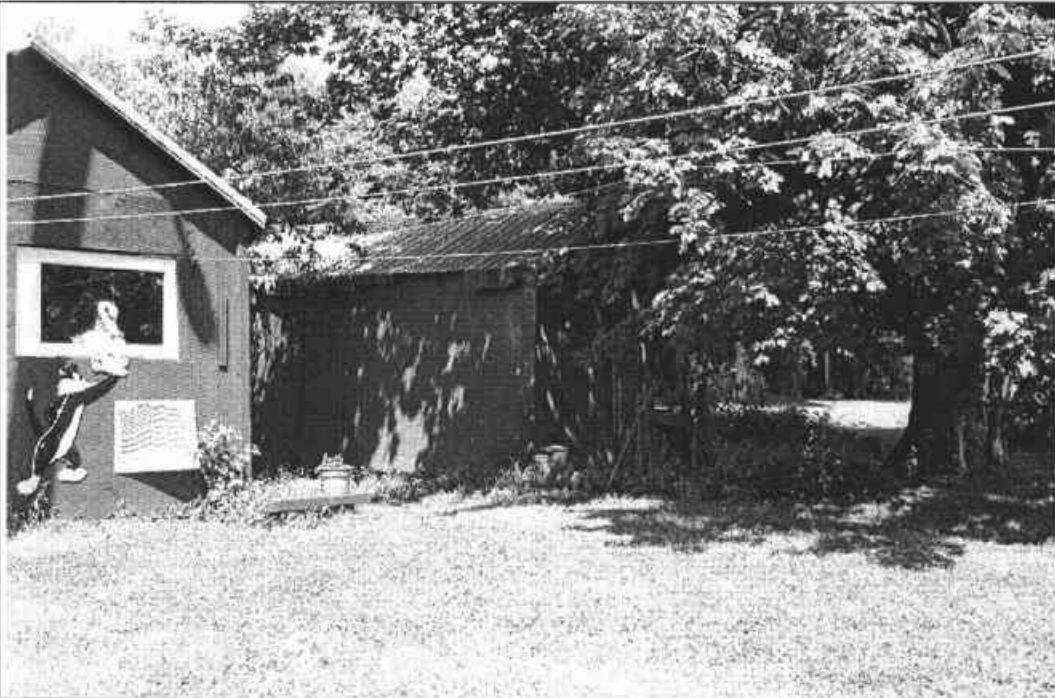
N05235. Photograph 5: Kate Kaiser House, shed, south elevation, view to northeast. This shed is located east of the two garages.

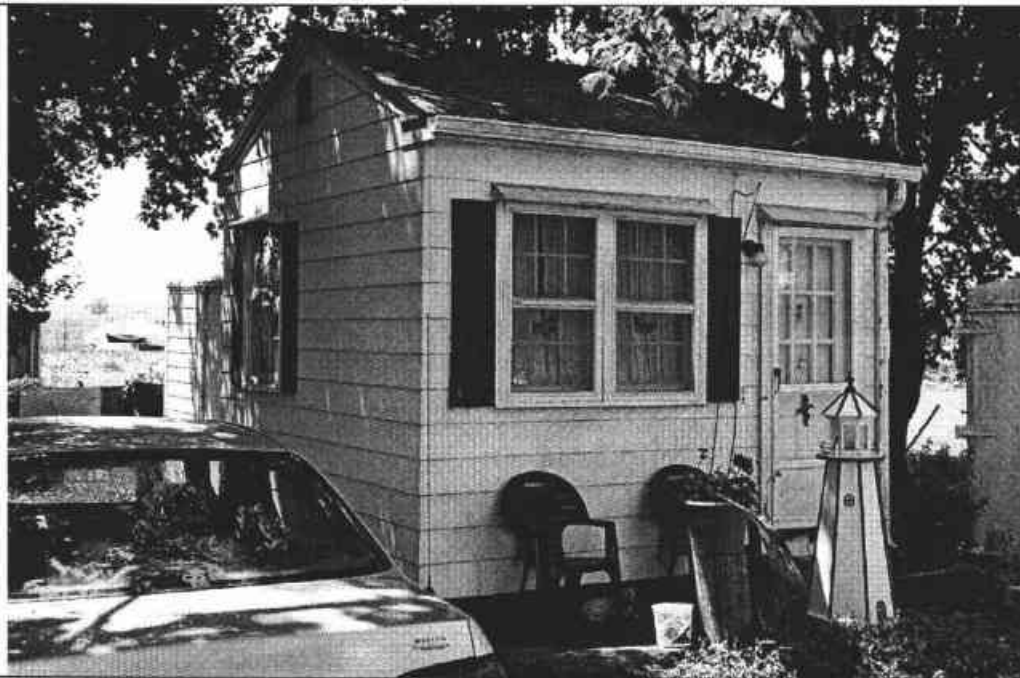
N05235, Photograph 6: Kate Kaiser House, office, east elevation, view to west. This building was moved to the property from an automobile dealer at Ginn's Corner.

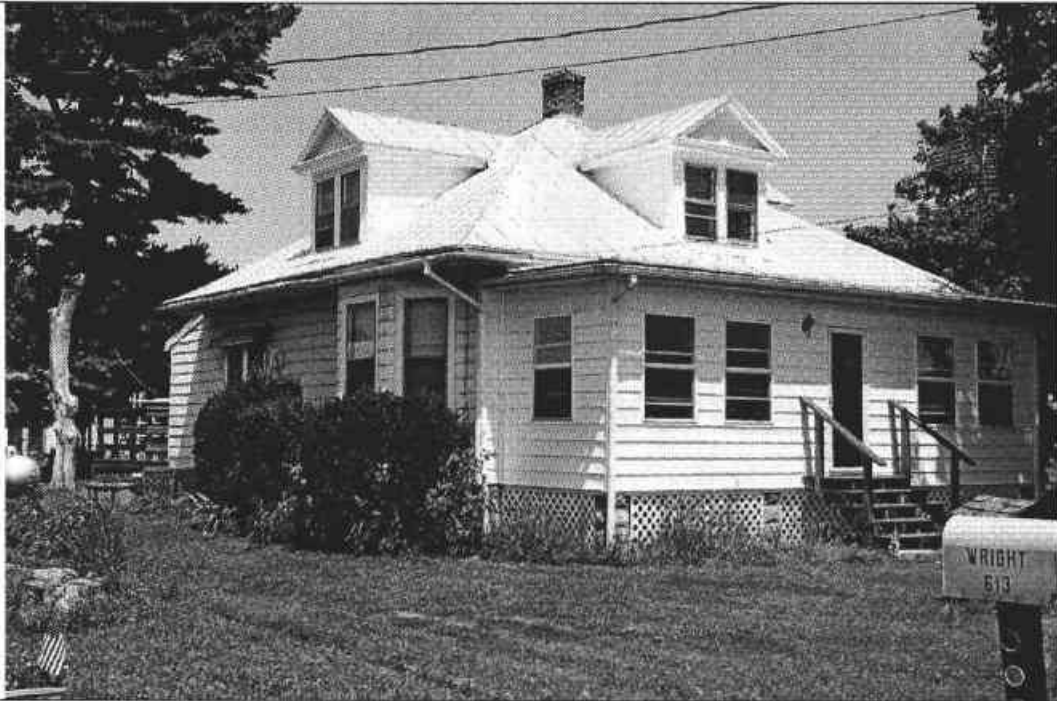
N05236. Photograph 1: Ida Holton House, south and west elevations, view to northeast. Note *circa*-2003 enclosed porch on the south elevation and replacement aluminum

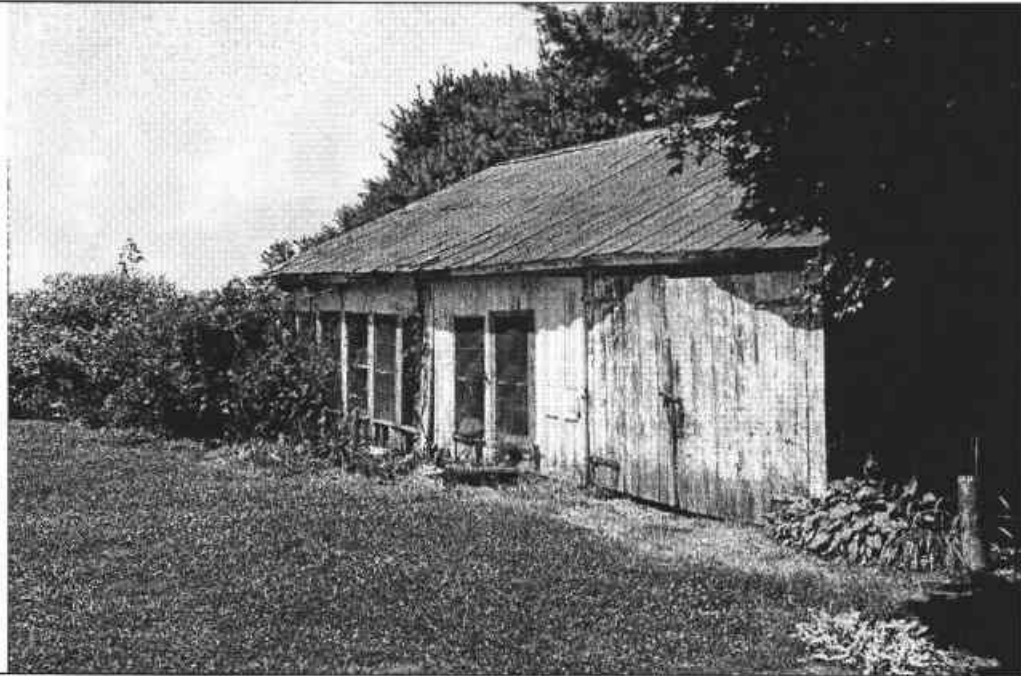
N05236. Photograph 2: Ida Holton House, shed #1, south elevation, view to northwest. Note batten doors, screened window bays, and general deteriorated condition of shed.

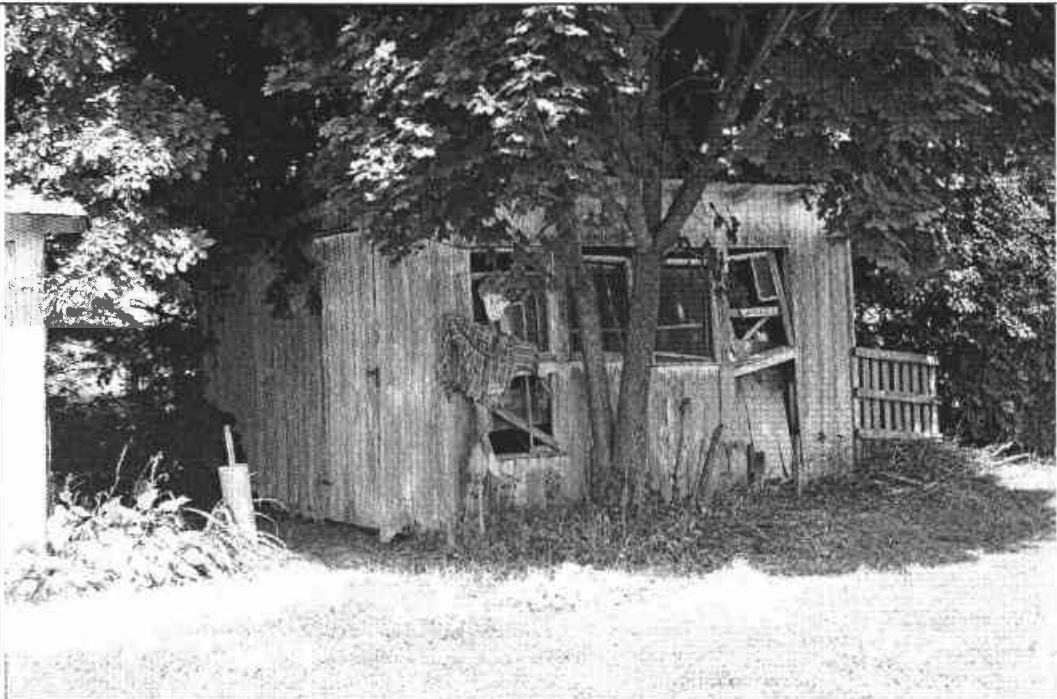
N05236. Photograph 3: Ida Holton House, shed #2, south elevation, view to north. Note deteriorated condition of shed.

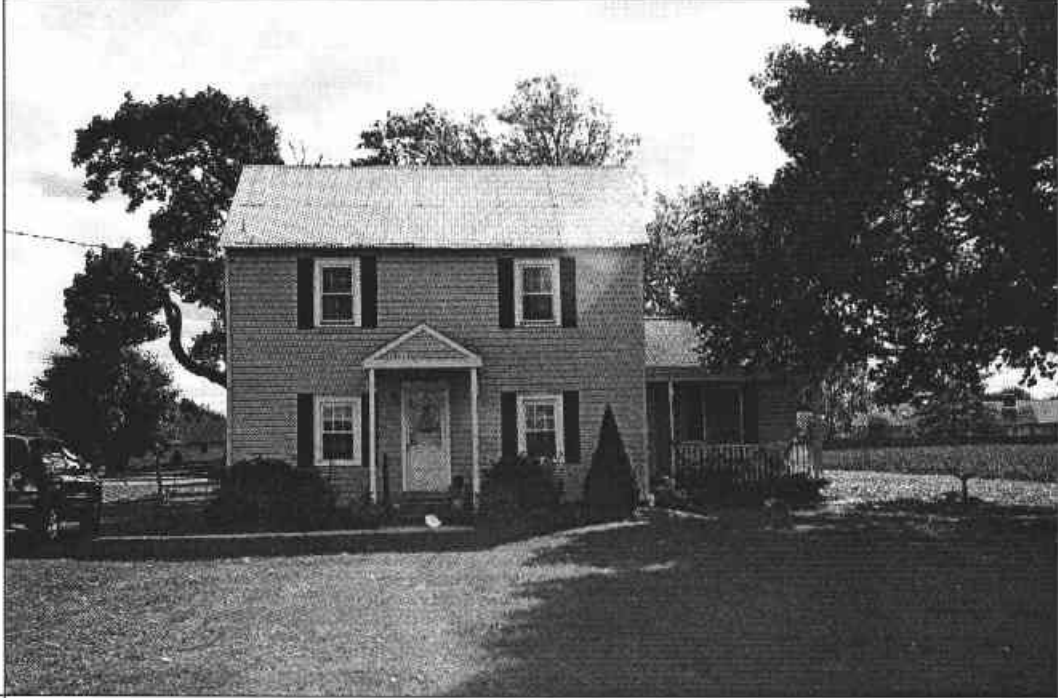
N05238. Photograph 5: Lynch Farm, tenant house, north elevation, view to south. Note later porch and addition as well as replacement windows and siding.

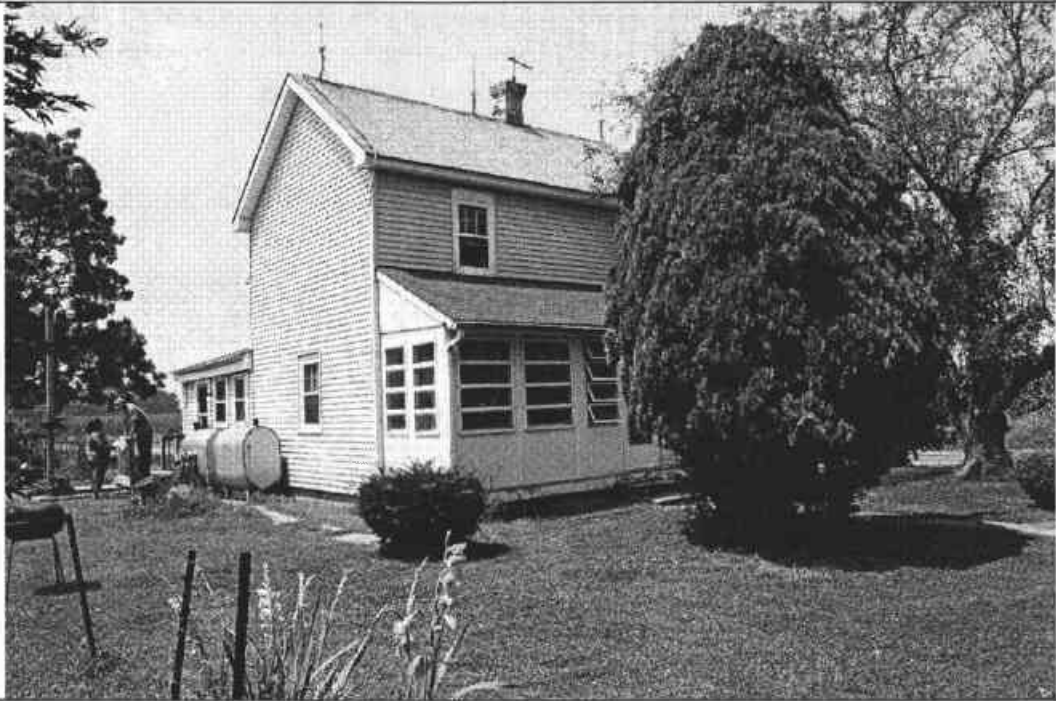
N05240. Photograph 1. G.F. Brady House, overview of house looking northwest, showing east and south elevations. Note enclosed porch on façade.

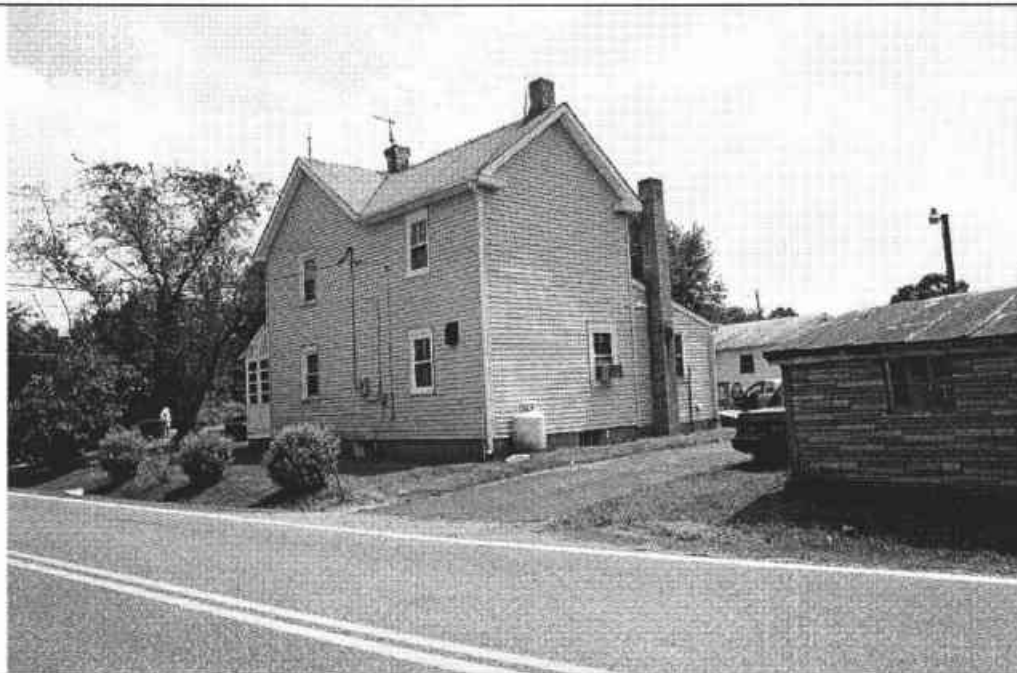
N05240, Photograph 2. G.F. Brady House, overview of house looking southeast, showing west and north elevations, showing rear ell with replaced exterior chimney and shed in foreground.

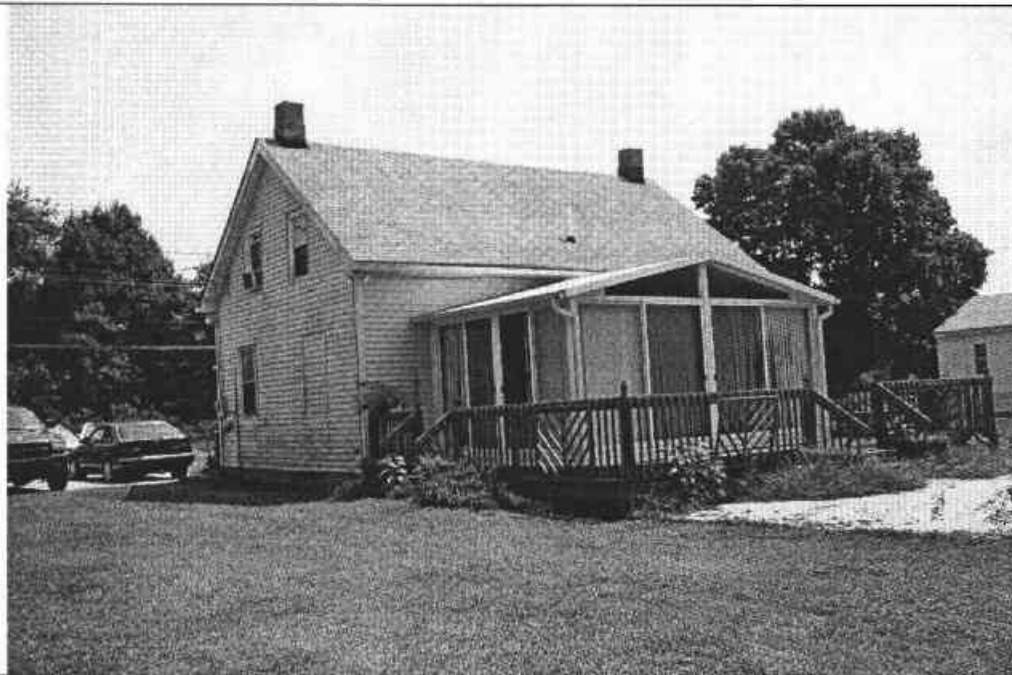
N05241. Photograph 2. S. Brady House, looking southeast, showing west and north elevations, with modern sunroom and deck.

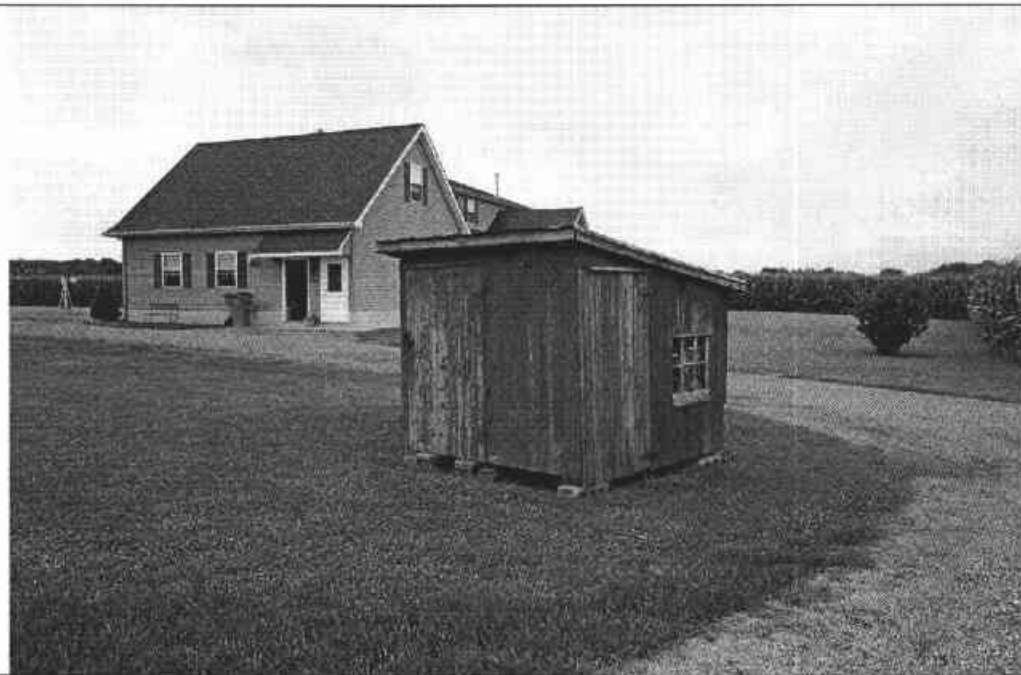
N05242. Photograph 10: North and west elevations of tool shed #2, looking southeast. Note modern dwelling, located on edge of farm complex, to the left.

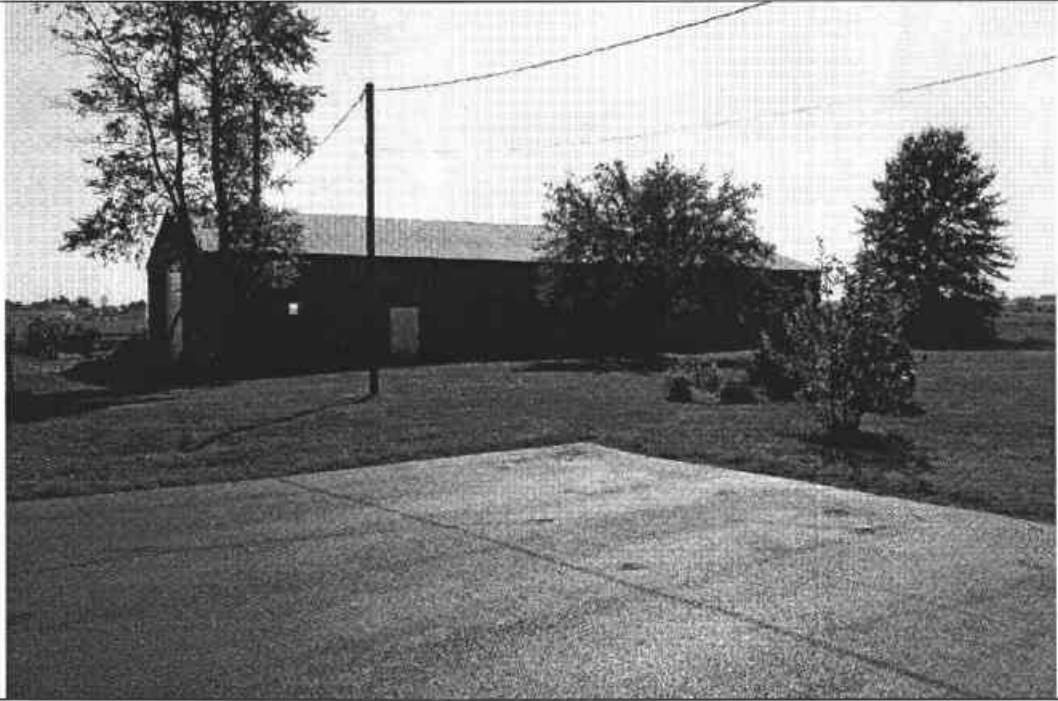
N05244. Photograph 3. Modern storage building/pole barn looking south.

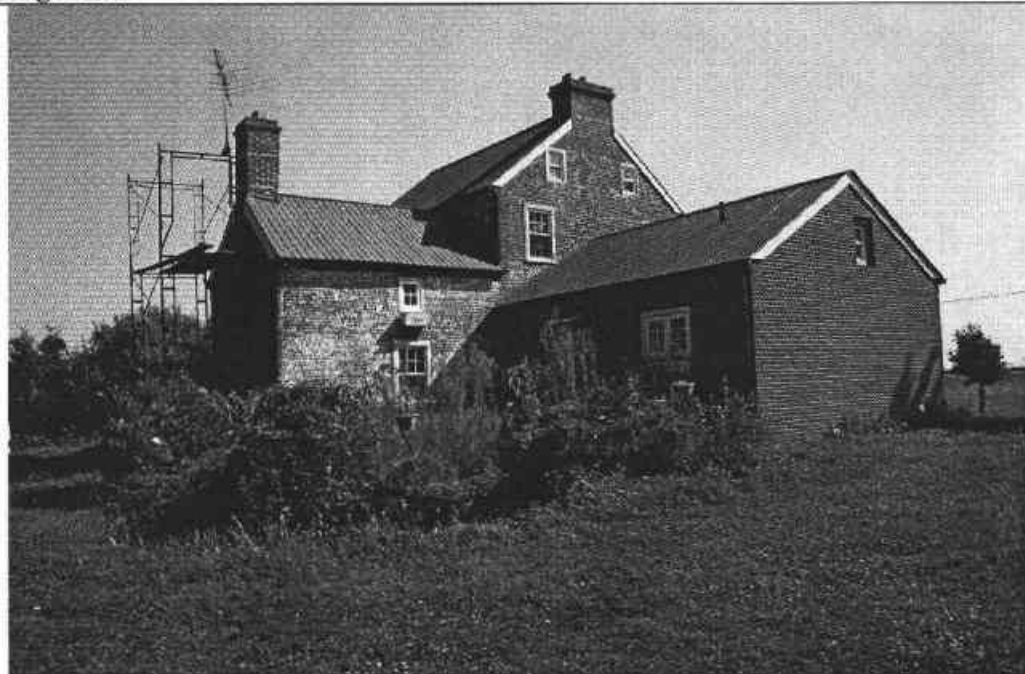
N05245. Photograph 2. Dwelling, north and west elevations, view to southeast. Note historic one-and-a-half-story brick ell to left of photograph, and modern brick addition in foreground.

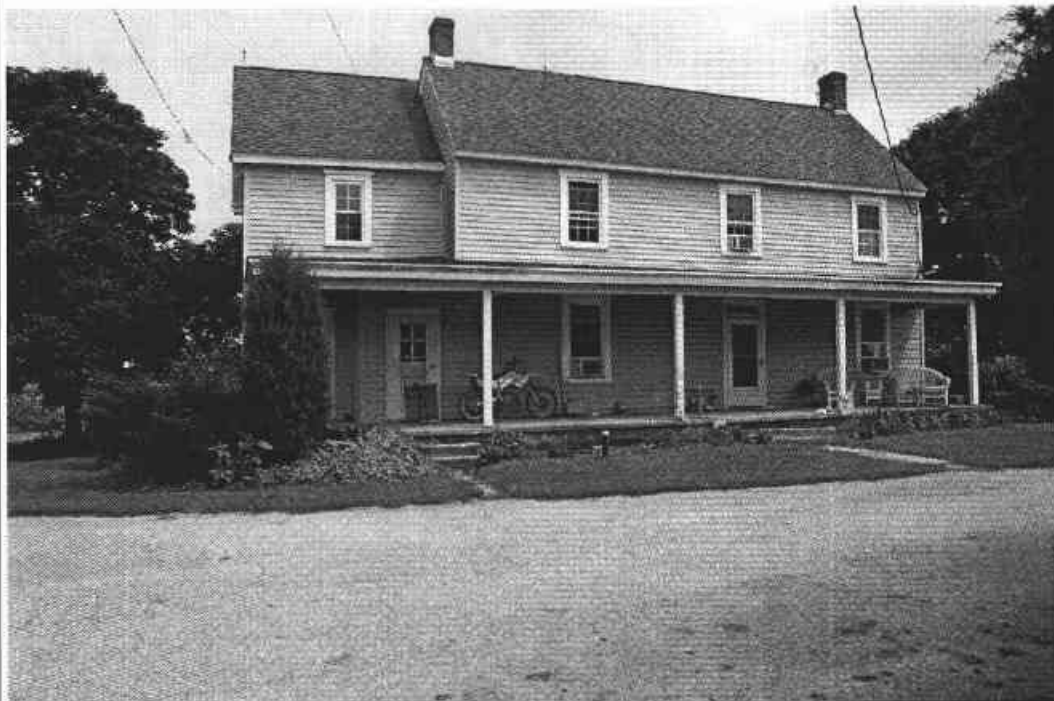
N05248. Photograph 1: Dwelling, façade, view to east. Note porch posts (replaced former porch posts with scroll work but are complimentary).

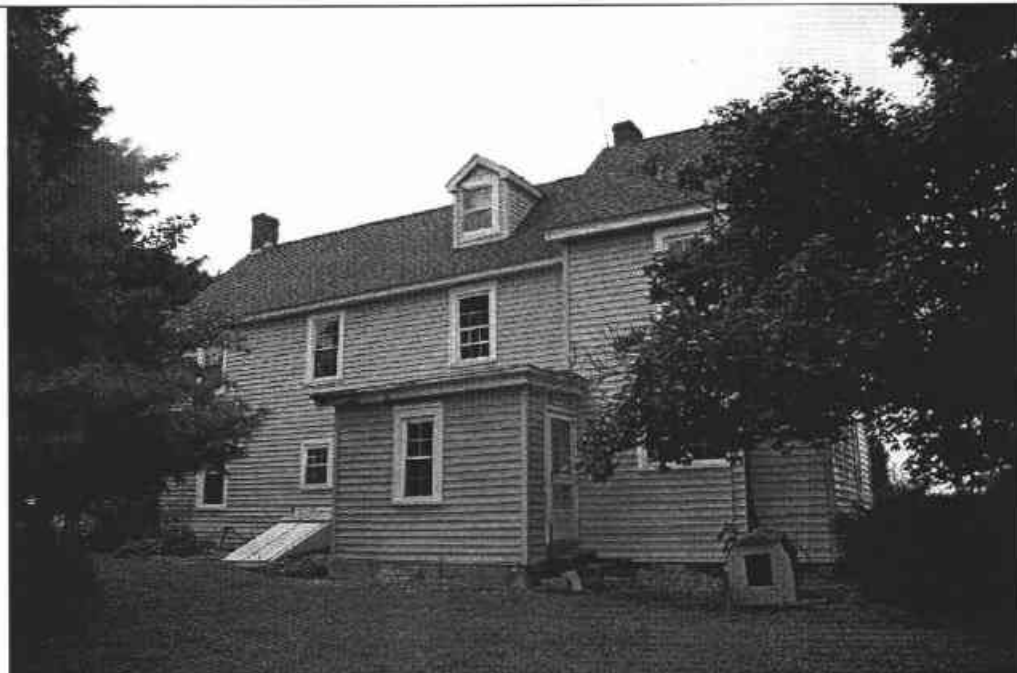
N05248. Photograph 2: Dwelling, rear (east) elevation, view to west. Note removal of former shed porch that covered storm cellar and overall retention of form and fenestration.

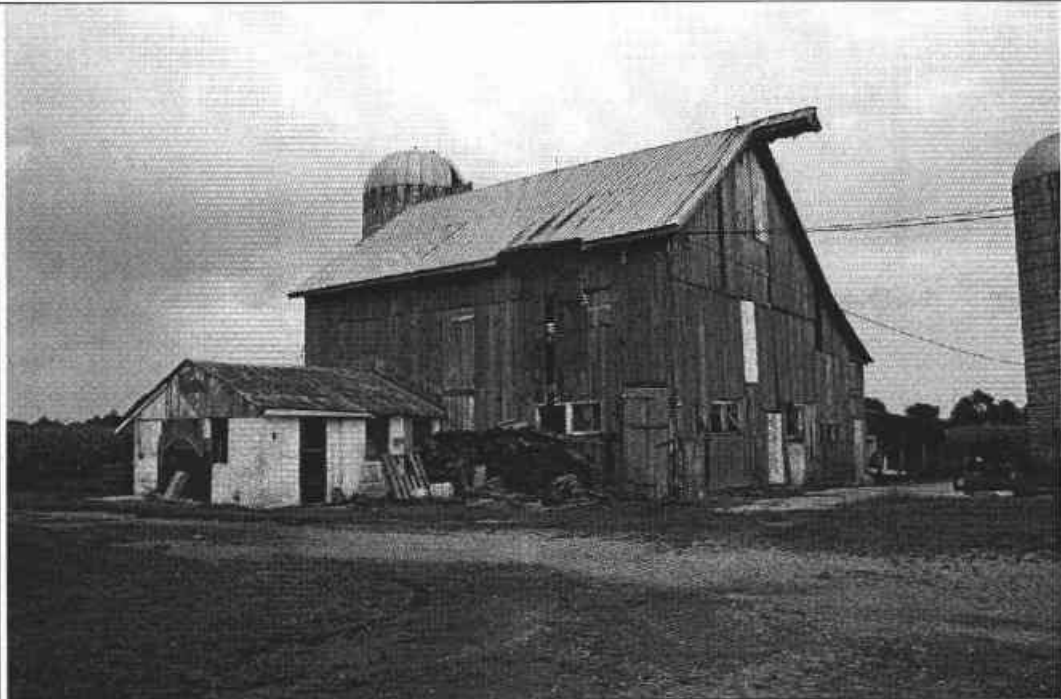
N05248. Photograph 3: Overview barn, view to northeast. Note milkhouse addition to left and retention of hayhood at south elevation.

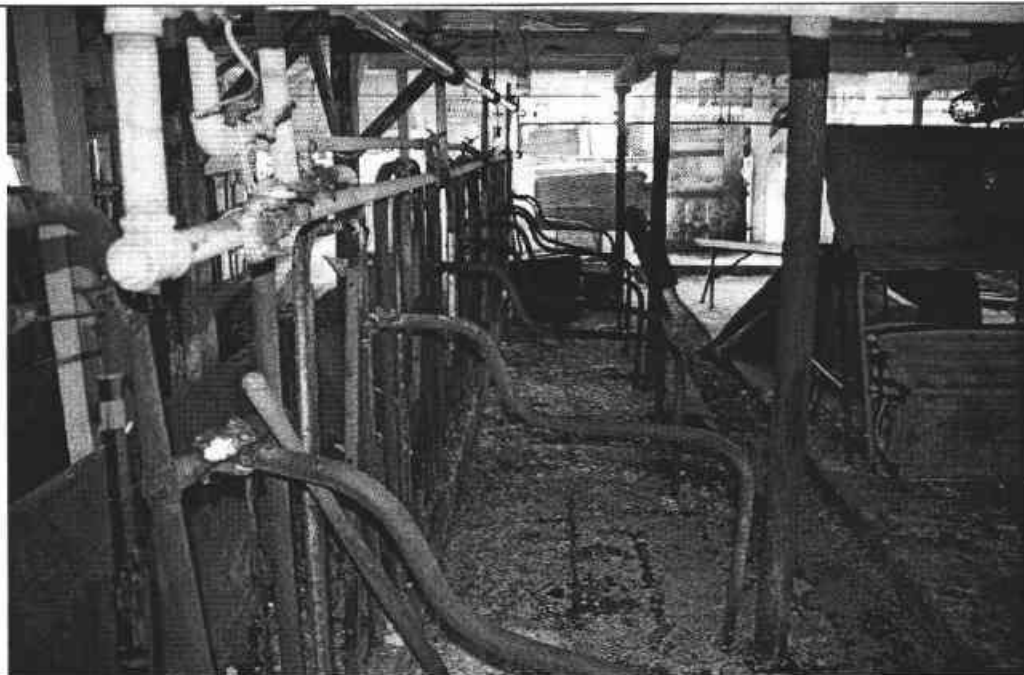
N05248. Photograph 4: Interior of barn, view to south. Note milking stanchions and glass tubing.

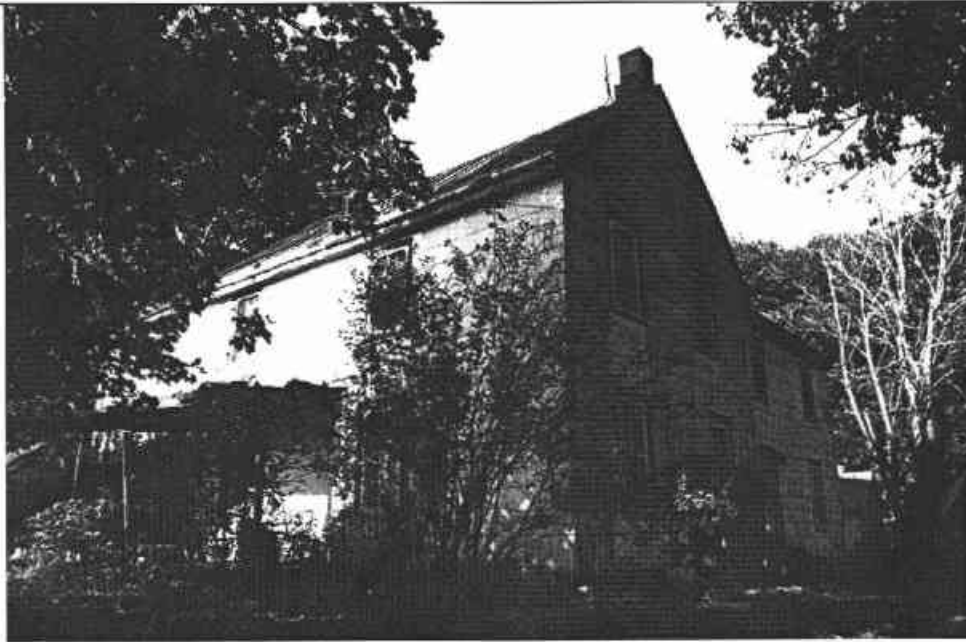
N06191. Photograph 1: Dwelling, north and east elevations, view to southwest. Note deterioration of front porch.

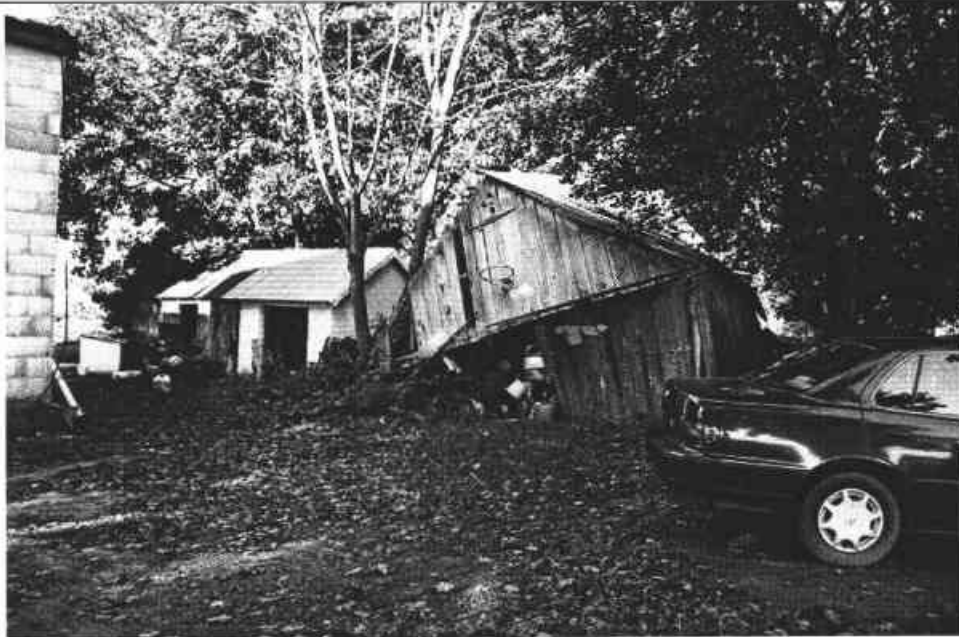
N06191. Photograph 3: Garage, east and north elevations, view to southwest. Note deteriorated condition.

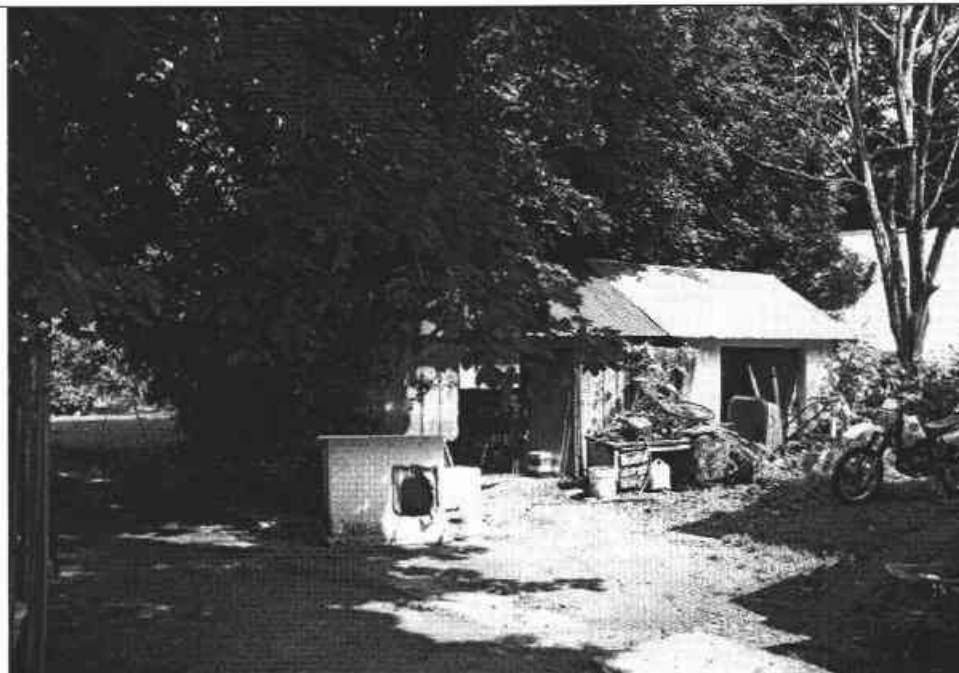
N06191. Photograph 4: Summer kitchen, east elevation, view to northwest. Note the large openings added to the front and the corrugated metal that now covers the roof.

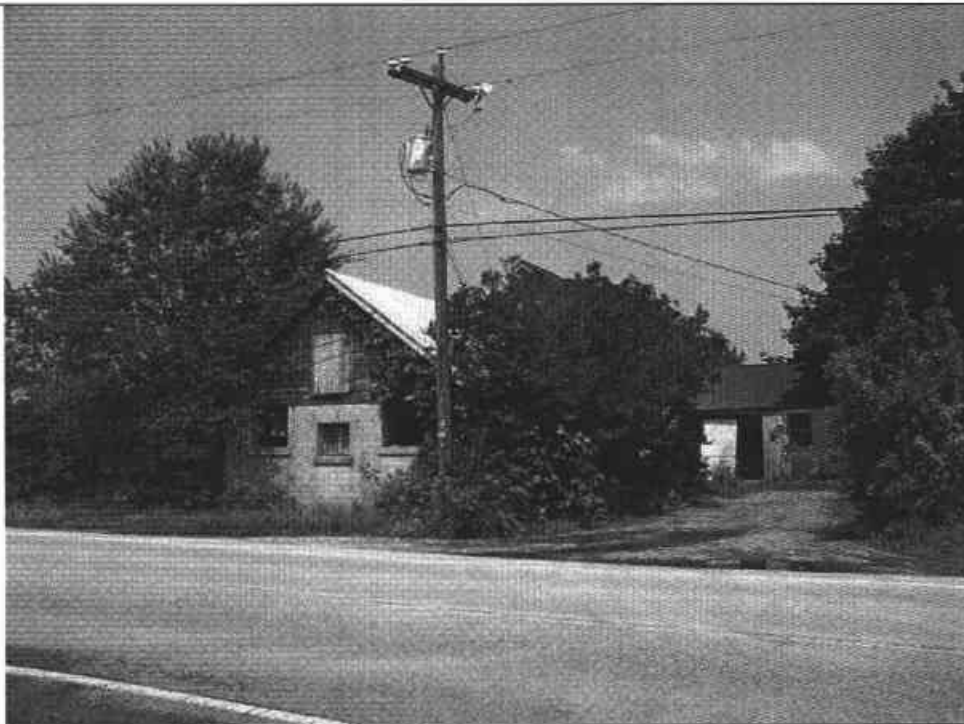
N06191. Photograph 5: Granary/dairy barn and milkhouse, east elevation, view to southwest. Note deteriorated condition and severe vegetation overgrowth.

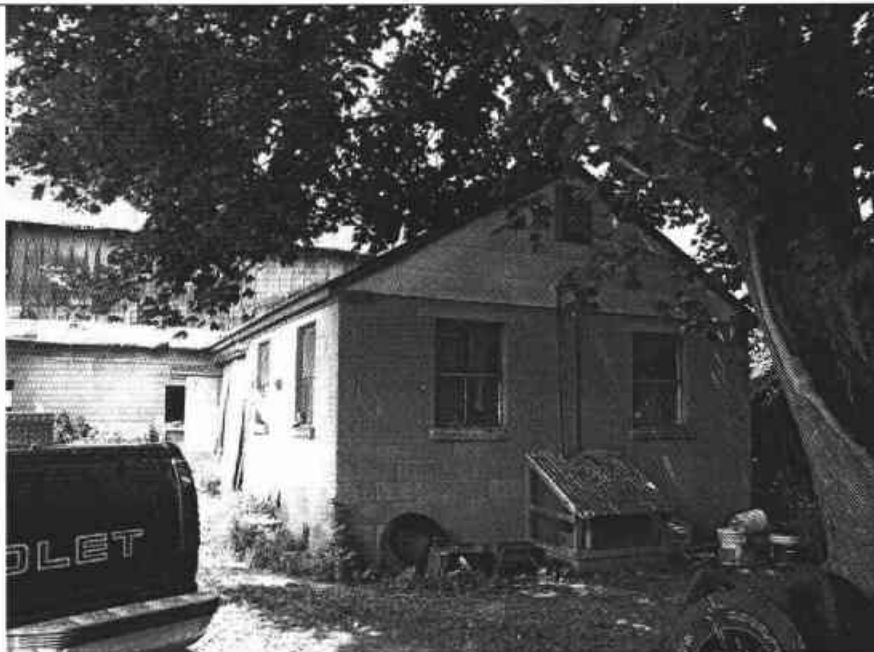
N06191. Photograph 6: Milkhouse, north and east elevations, view to southwest. The milkhouse is attached directly to the north elevation of the granary/dairy barn.

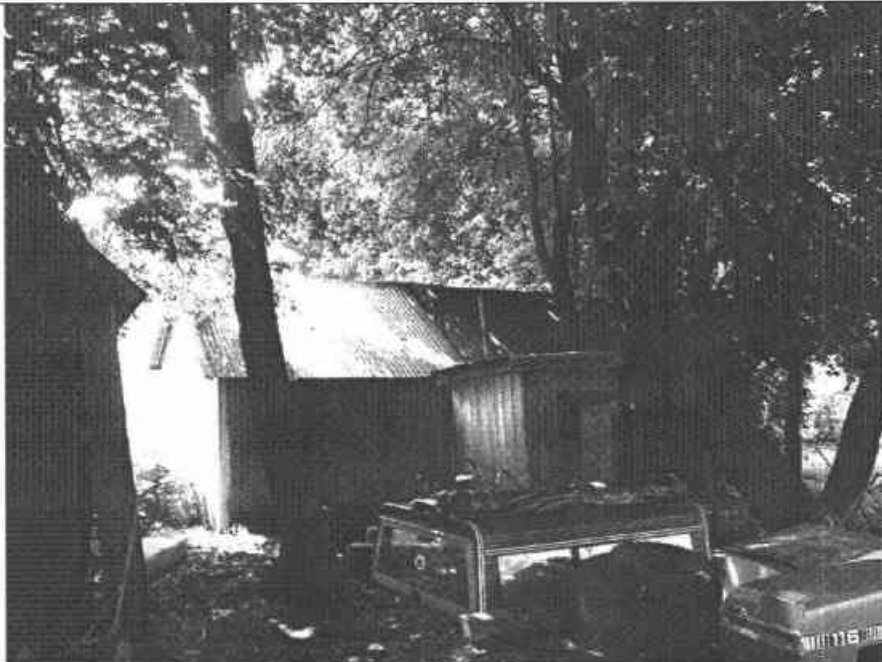
N06191. Photograph 7: Privy #2, west and north elevations, view to southeast. Note west and north elevations of summer kitchen in background and southwest corner of privy #1 in foreground.

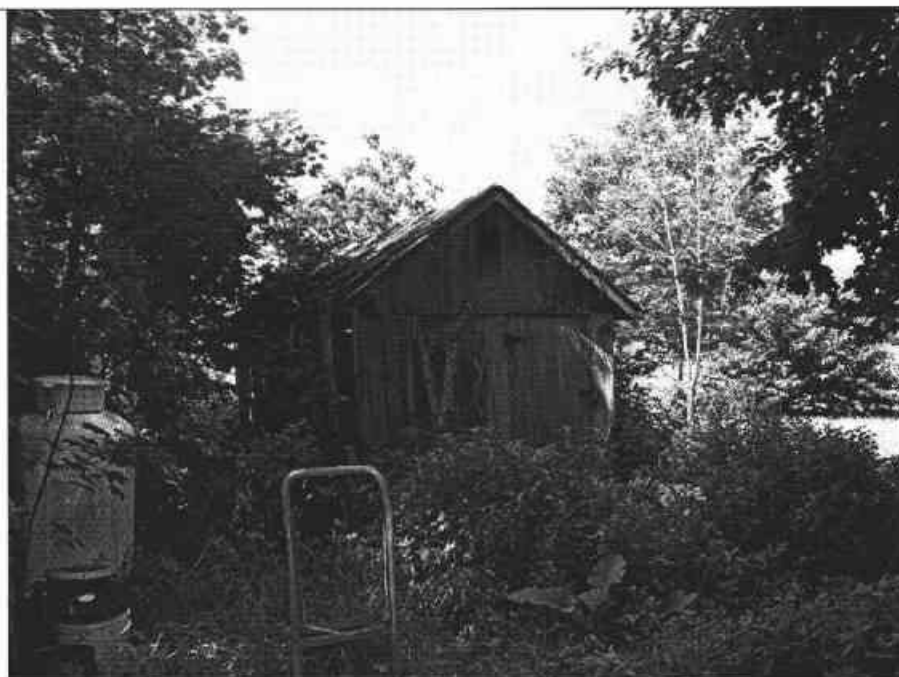
N06191. Photograph 8: Shed, east and south elevations, view to northwest. Note deteriorated condition and vegetation overgrowth.

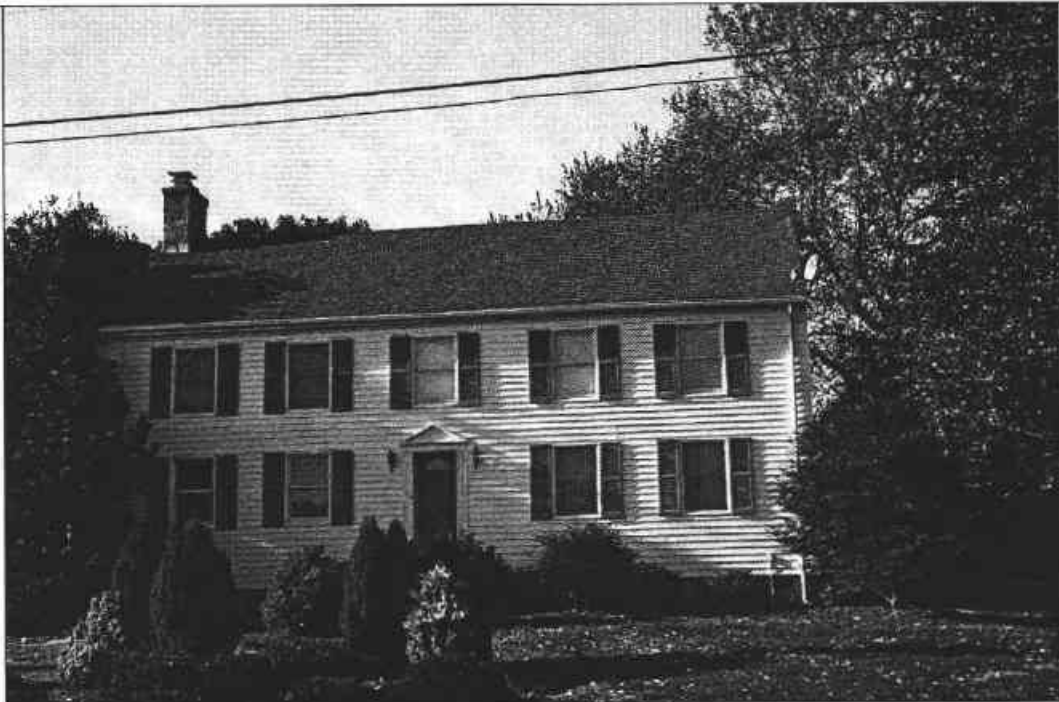
N06320. Photograph 1: Dwelling, south elevation, view to north. Note door surround and landscaped lawn.

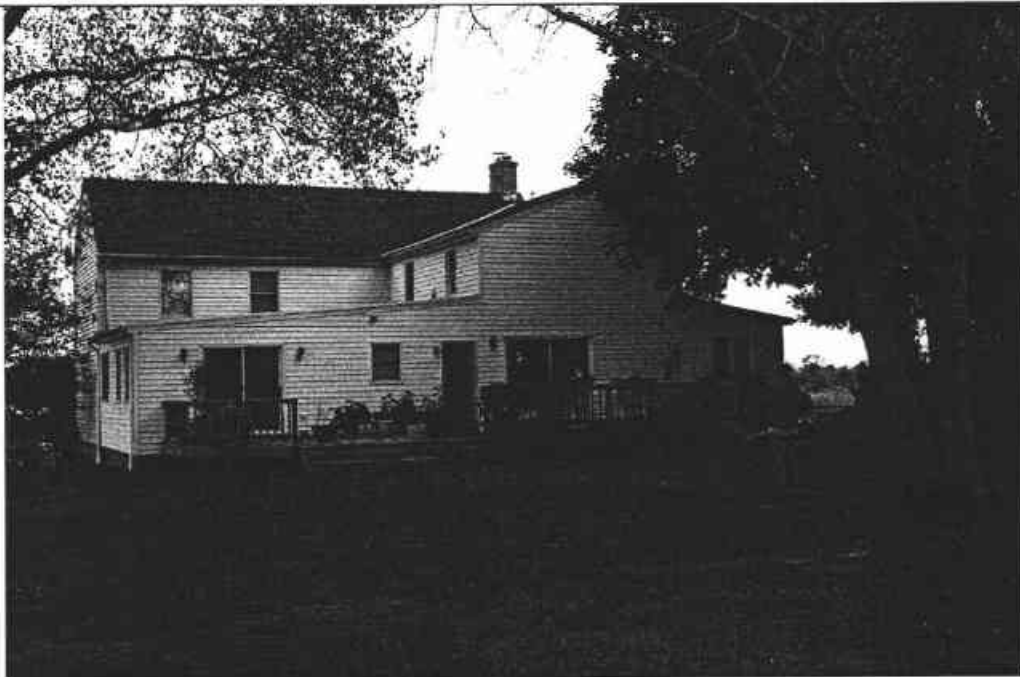
N06320. Photograph 2: Dwelling, north and east elevations, view to south. Note additions to rear ell and the modern deck that extends the length of the northern elevation.

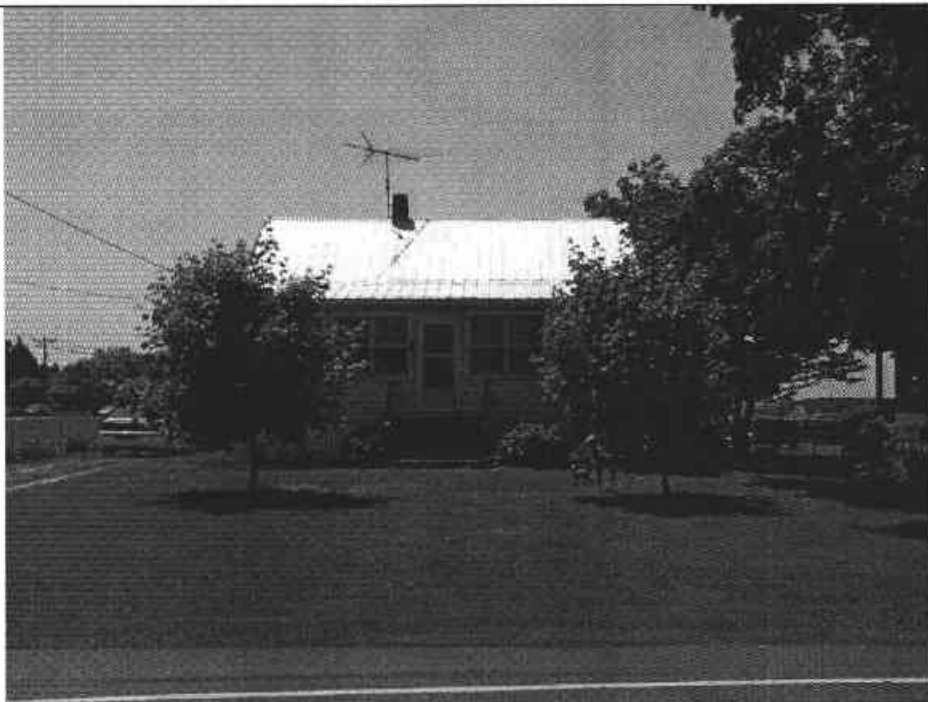
N12018. Photograph 1: Dwelling, north elevation, view to south. This bungalow, a common property type found throughout the U.S. 301 study area, is clad in aluminum siding and the front porch has been enclosed.

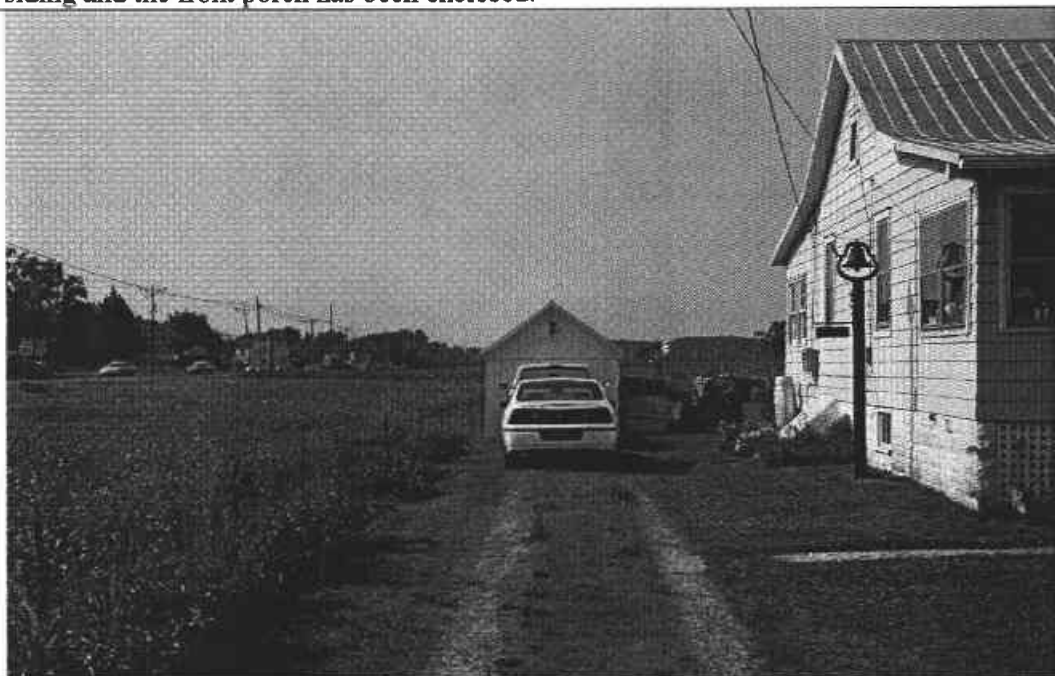
N12018. Photograph 2: Dwelling, east elevation, and garage, north elevation, view to south. Note enclosed porch and different window types lighting the dwelling's interior. Also note vacant lot and heavy traffic on Summit Bridge Road (U.S. 301)..
